## Appendices

Appendix Three: Ghūrīd sites

Appendix Ten: descriptions of Ghurid sites analysed in high resolution satellite images available through Google Earth

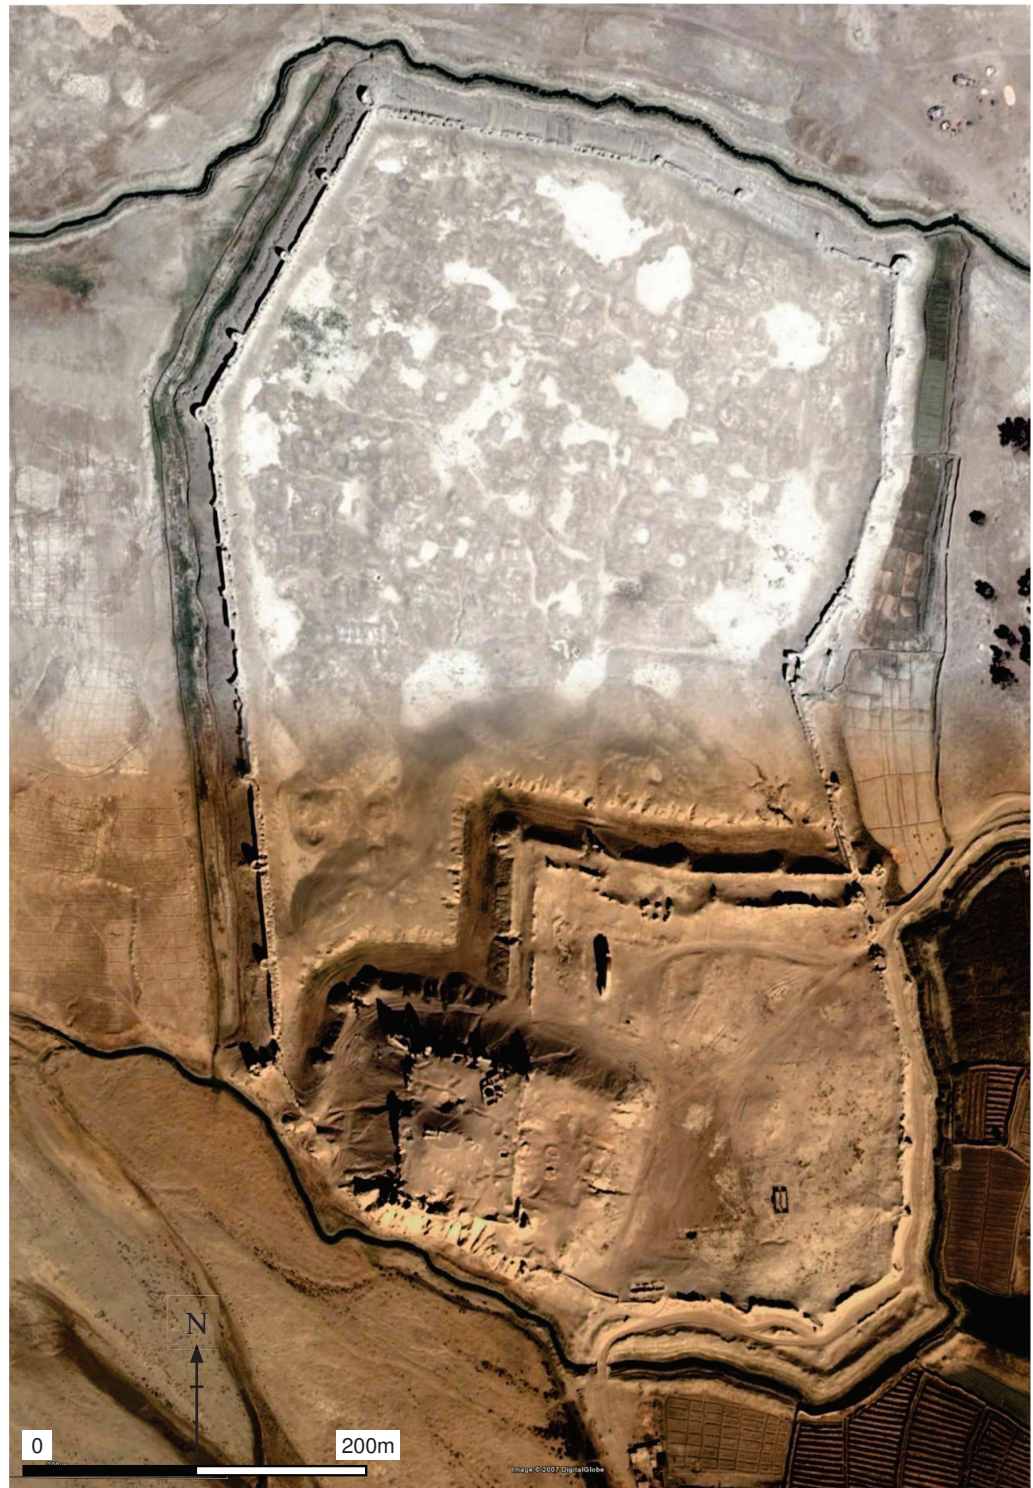
A10:3 Gazetteer Site 149 – Bust citadel

Gaz. No.	Description derived from satellite image available through Google Earth
	<p><b>Bust Citadel</b> (Figs A10:3-4): the fortifications of the fortress, citadel and lower walled town, and the monumental arch stand out dramatically in the satellite images of the <b>Bust Citadel</b>, available through Google Earth despite the different exposures of the stitched images. The remnants of a major earlier (Parthian?) wall, which is sketched on Schlumberger's Planche 2, are evident to the west of the lower walled town. An array of 'residences', courtyard buildings, walled enclosures (gardens?), canals and other less identifiable structures are visible in the satellite images available throughout Google Earth, particularly within the lower walled town at the foot of the citadel, and to the north of the citadel, and to the west may indicate the pooling of water in formerly open spaces.</p>
	<p><b>Bust SW</b> (Fig. A10:5): this strip of images covers a 770 m (north-south) area along the bank of the Hilmand, to the west of the citadel. The principal structure is <b>Residence XI</b>, which measures 93 x 72 m and is orientated north-south. Its west wall is relatively well preserved, particularly the south part, where towers are extant. The 7 m long gap in the west wall may indicate an entrance, leading to the river. The rest of the perimeter wall outlines are generally visible, but little detail can be discerned. Similarly, few internal structures are readily recognisable. The large rectangular white patch in the centre (41 x 23 m) may reflect (literally) silting. Cultivation is currently not very prevalent on this part of the site, but extensive, relatively recent field systems are evident in several areas. In the south, the outline of ramparts are visible (they are light coloured, probably indicating a lack of vegetation growing on the packed earth), but again, these are poorly preserved. Allen (1988: 58) argues that these date to the Parthian period and enclose the Parthian city. Trenches F2 and F3 might be identifiable in this area, but they would probably not be recognised as such were it not for Planche 2. To the south of <b>Residence XI</b> is an area of what appears to be walled gardens, which might be confused for structures if it were not for the vegetation. Further east, rectilinear marks may indicate similar cultivation features, or possibly ancient structures. Several small, grey 'rough' areas might indicate low mounds, possibly covered with graves.</p>

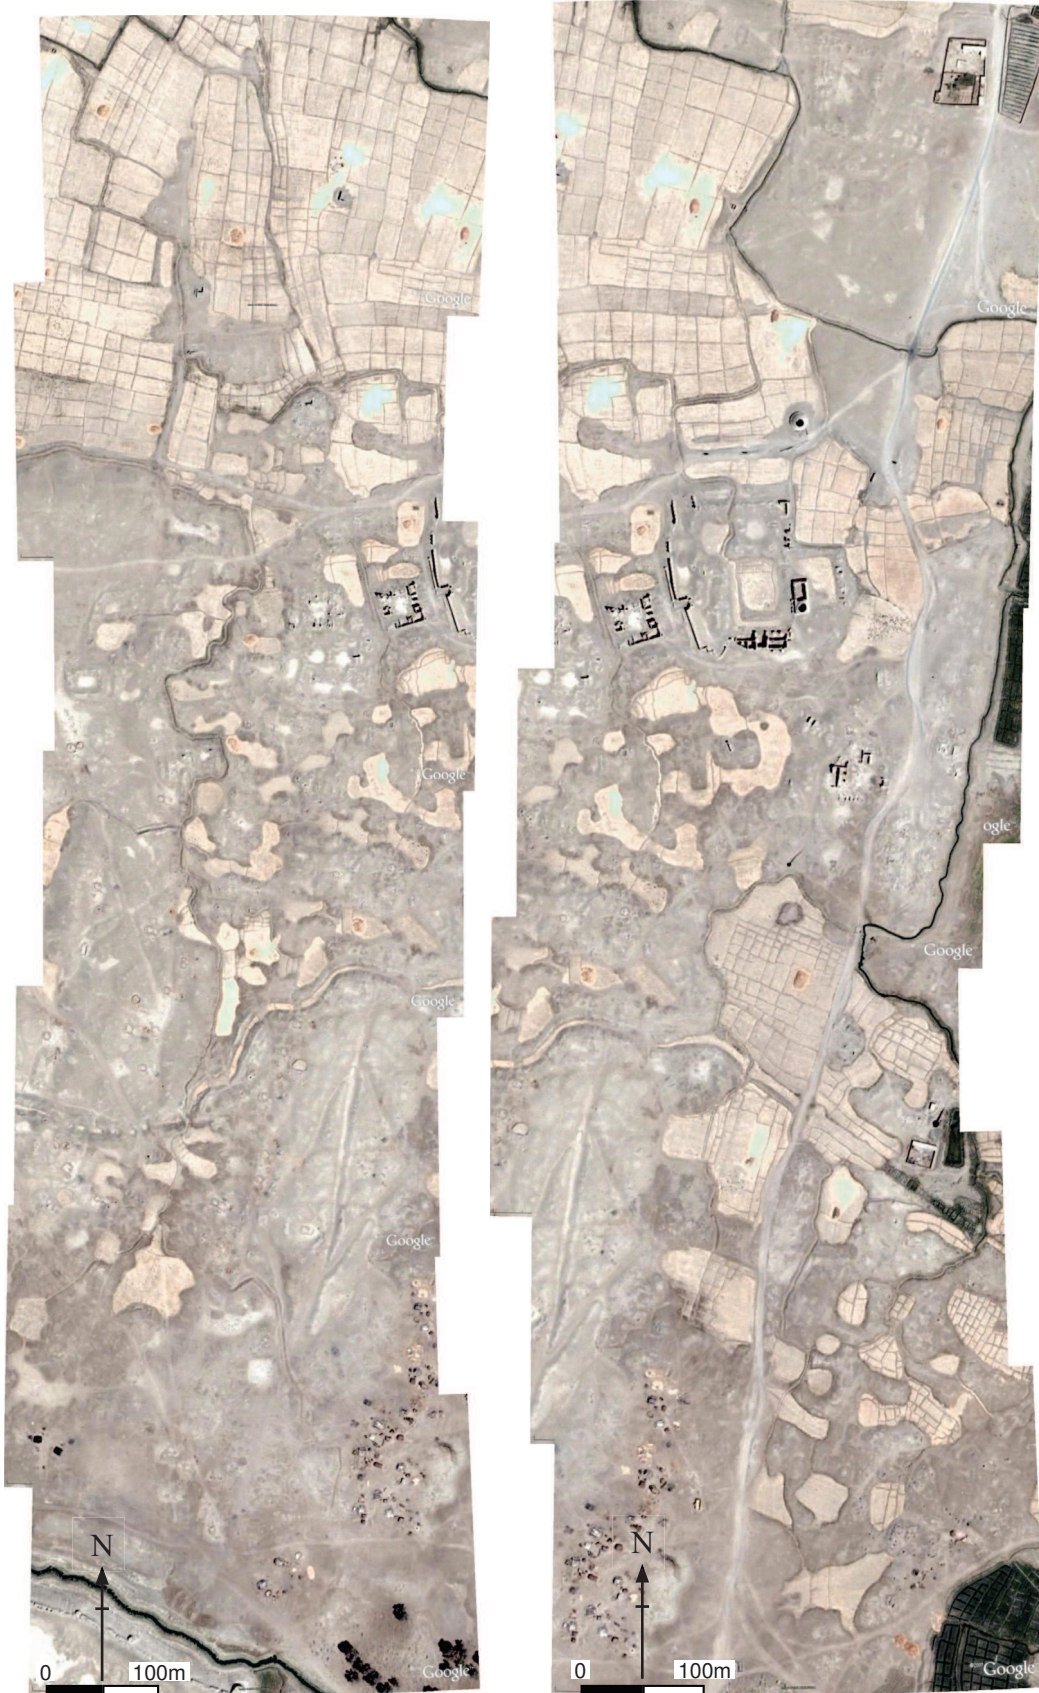
A10:10 Bust ECentral (left) and Bust East (right)

<p><b>Bust ECentral</b> (Fig. A10:10): the nomad camp in the south-east of this image provides a useful explanation of some of the nearby sub-circular features that are visible in this strip. As in <b>Bust Central</b>, their concentration along ancient canal lines and lines of karez spoil-heaps / wells is also indicative of their probable function as recent animal pens. Some of the darker patches around the light silty areas probably represent vegetation which would have grown longer in these damper areas and provided fodder. Elsewhere, however, intense small dark spots may indicate ancient industrial refuse / slag heaps. In general, the archaeological remains in this area are not well preserved. Little is visible in the north where harvested fields dominate and the plethora of 'dried up lagoons / ponding' features in the centre make the identification of building outlines difficult. If this interpretation is correct, however, and this was a perennially damp / marshy area, occupation in this part of the site may have been limited anyway. In the south, a couple of rectilinear outlines are noticeable close to the citadel walls, but little can be said about these, and several other possible structures to the north. Only when we reach the vicinity of <b>Résidence XIII</b> are building outlines clearer, but even here, few have the upstanding architecture of <b>Résidence XIII</b> and only rough outlines can be delineated. Given these limitations, measurements of these structures were not taken.</p>
